# **APPENDIX L** LIFT STATION FIELD EVALUATIONS

Bonney Lake Lift Station Notes – Following list station observation conducted on 06/14/2016

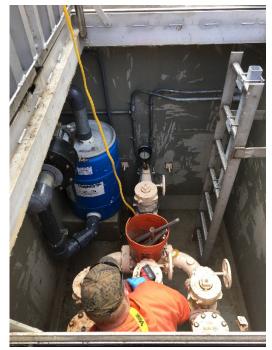
#### <u>LS 2</u> – 9914 176<sup>th</sup> Ave. E.

- No general issues or odor issues
- This station is not equipped with the cities standard "Flygt" pumps
- Future development coming to this station
- Bioxide present at station

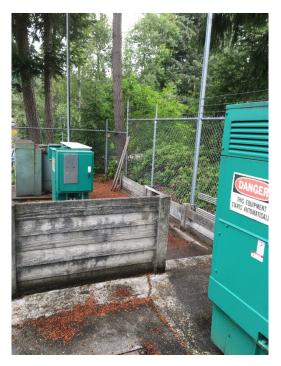
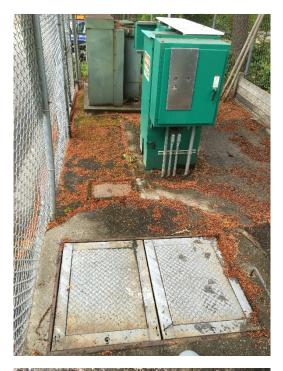
## <u>LS 3</u> – 18704 82<sup>nd</sup> St. E.

- No general issues or odor issues
- Station services a school
- Handles a large amount of grease from the school

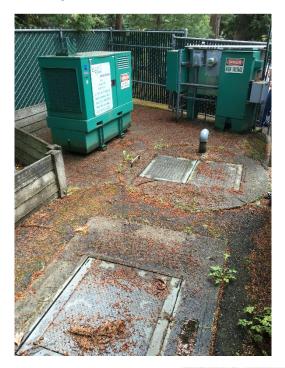
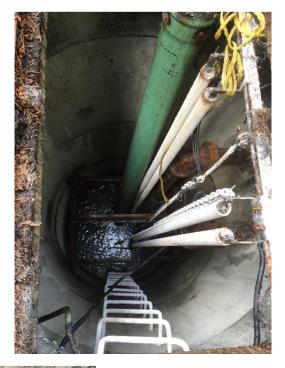
## <u>LS 4</u> – 18308 77<sup>th</sup> St. E.

• No general issues or odor issues

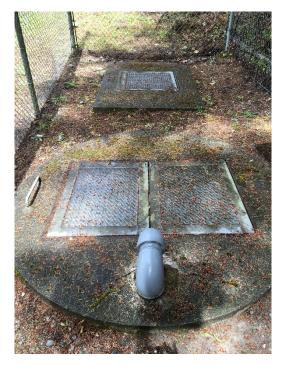
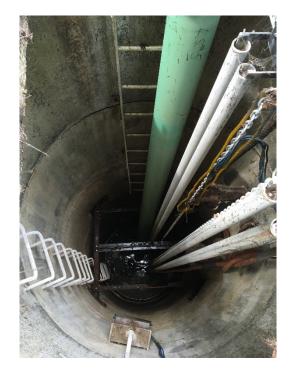
## <u>LS 5</u> – 7002 Myers Road

- No general issues or odor issues
- Very small service area

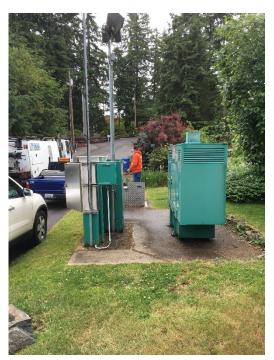
## <u>LS 6</u> – 18723 A Mcghee Drive

- No general issues or odor issues
- Low flow station
- Pump only has 1400 hours from the last 31 years

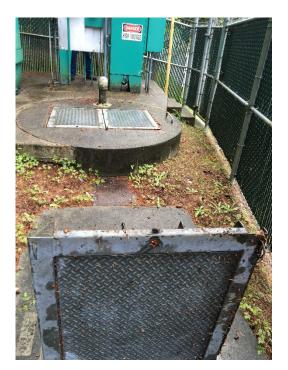
## <u>LS 7</u> – 19307 65<sup>th</sup> St. E.

- No general issues or odor issues
- Low flow station

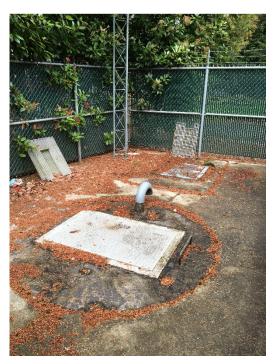
## <u>LS 8</u> – 6603 185<sup>th</sup> Ave. E.

• No general issues or odor issues

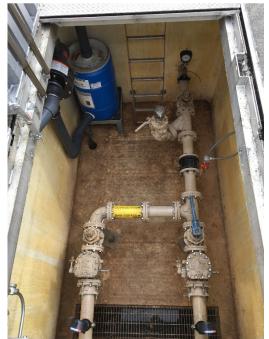
#### <u>LS 9</u> – 9300 225<sup>th</sup> Ave. E.

- Take a further look at future options for this station
- Very shallow wet well
- Long problematic force main leaving this station
- Bioxide present at station but not used
- Floor drain in valve vault does not drain effectively

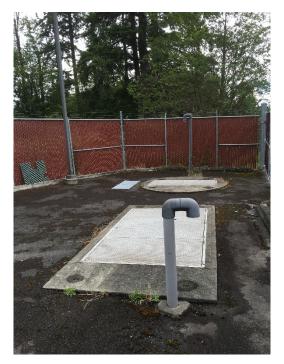
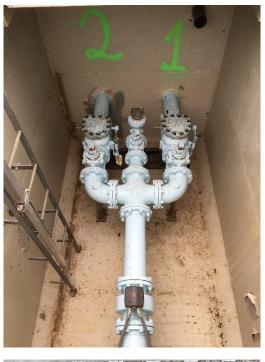
#### LS 10 – 22609 Connells Prairie Rd.

- No odor issues
- Bioxide present

- Minor coating issues in valve vault
  - This station scheduled to be upgraded
    - Two future lift stations to come to this station

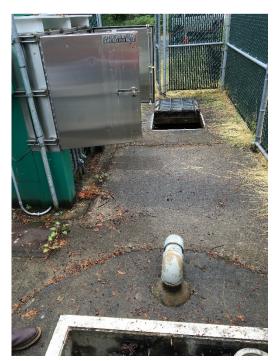
## <u>LS 11</u> – 5531 W. Tapps HWY

• No general issues or odor issues

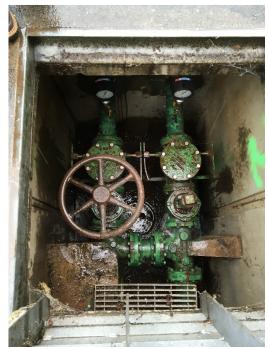
## <u>LS 12</u> – 20601 60<sup>th</sup> St. E.

- No general issues or odor issues
- Twin of station 16

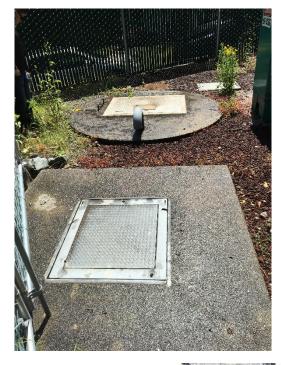
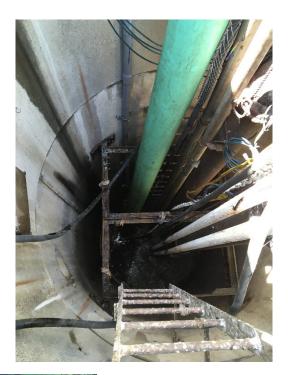
## LS 13 – 20919 Church Lake Drive

- No general issues or odor issues
- Newer pressure transducer

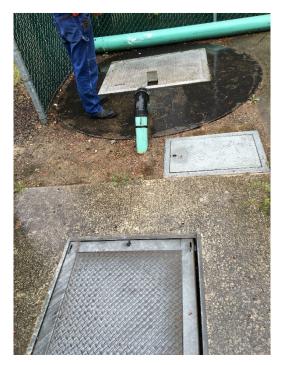
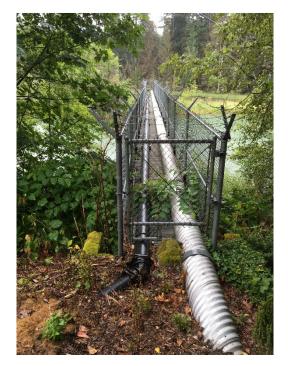
## <u>LS 14</u> – 21002 64<sup>th</sup> St. E.

- No odor issues
- Discharge piping and guide rails showing signs of age and rust
- Force main leaving this station runs over the lake on a bridge alongside water main

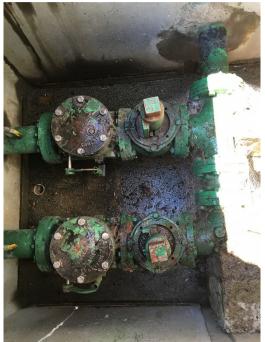
## LS 15 – 7418-A Vandermark Road

- No odor issues
- Discharge piping slightly rusty
- Low flow station

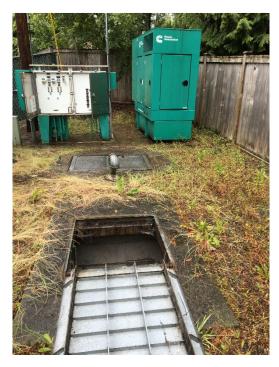
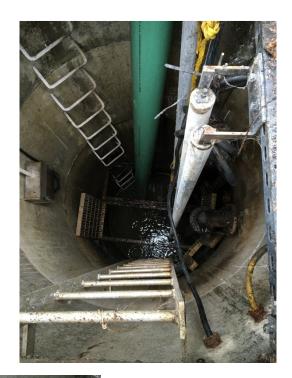
## <u>LS 16</u> – 20825 60<sup>th</sup> St. E.

- No general issues or odor issues
- Twin of station 12
- Largely fed by grinder pump stations

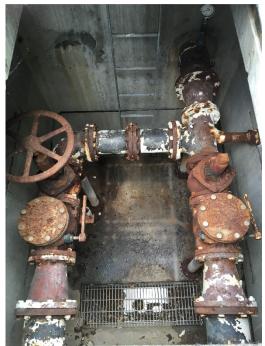
#### <u>LS 18</u> – 21301 S.R.-410

- No odor issues
- Coal tar epoxy coating in wet-well coming off of lower walls
- Possible new lift station being put in near here in the future

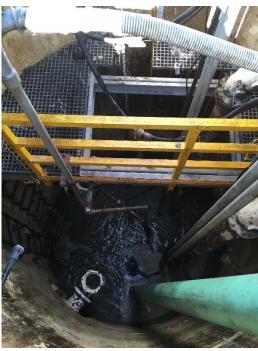
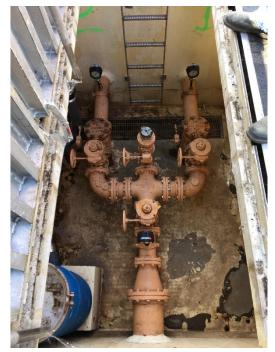
## LS 19 – Willowbrook (Address not listed on sign)

- No odor issues
- Bioxide present
- Wet-well coating peeling in various locations
- Bypass pumping port at this station

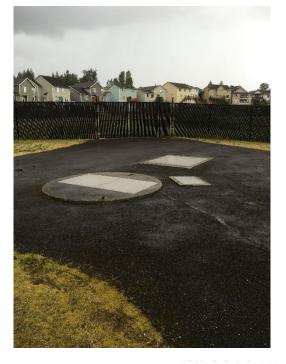
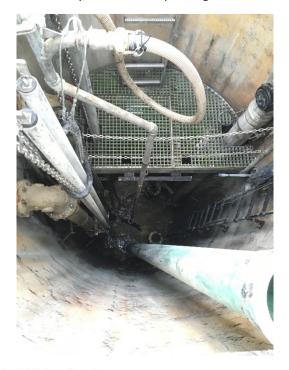
LS 20 – Spring Haven (Address not listed on sign)

- No odor issues
- Coating failures in wet-well and valve vault due to H2S coming from station 9
- Station has an ultrasonic transducer which was installed recently and is already failing

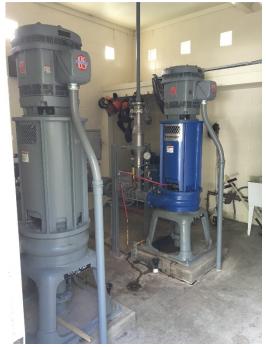
<u>LS 21 cont.</u> – West Hill Dr.

- No general issues or odor issues
- Charcoal filters used for odor control
- Availability for a third pump
- Pumps at this station were specifically designed for this station
  o Having a spare pump would be useful
- Building present

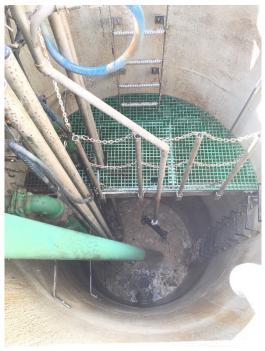
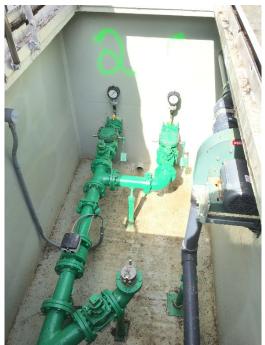
## LS 22 – Brookfield (Address not listed on sign)

- No general issues or odor issues
- Bioxide present
- Fed largely by grinder pump stations
- Pig port present

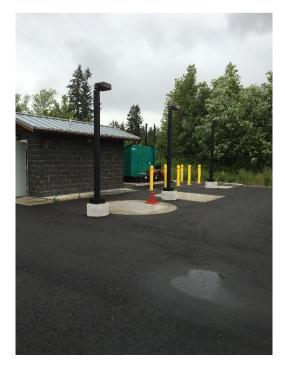
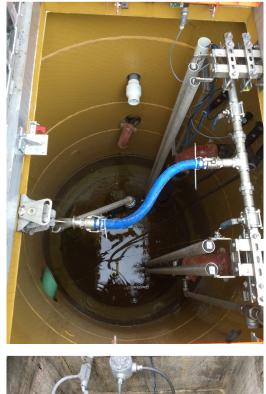
## <u>LS 23</u> – 22225 96<sup>th</sup> St. East

• Not yet operational
